Aged Transformer Fire Risk Study - Life Safety Assessment

EEA Conference & Exhibition 2013, 19-21 June, Auckland

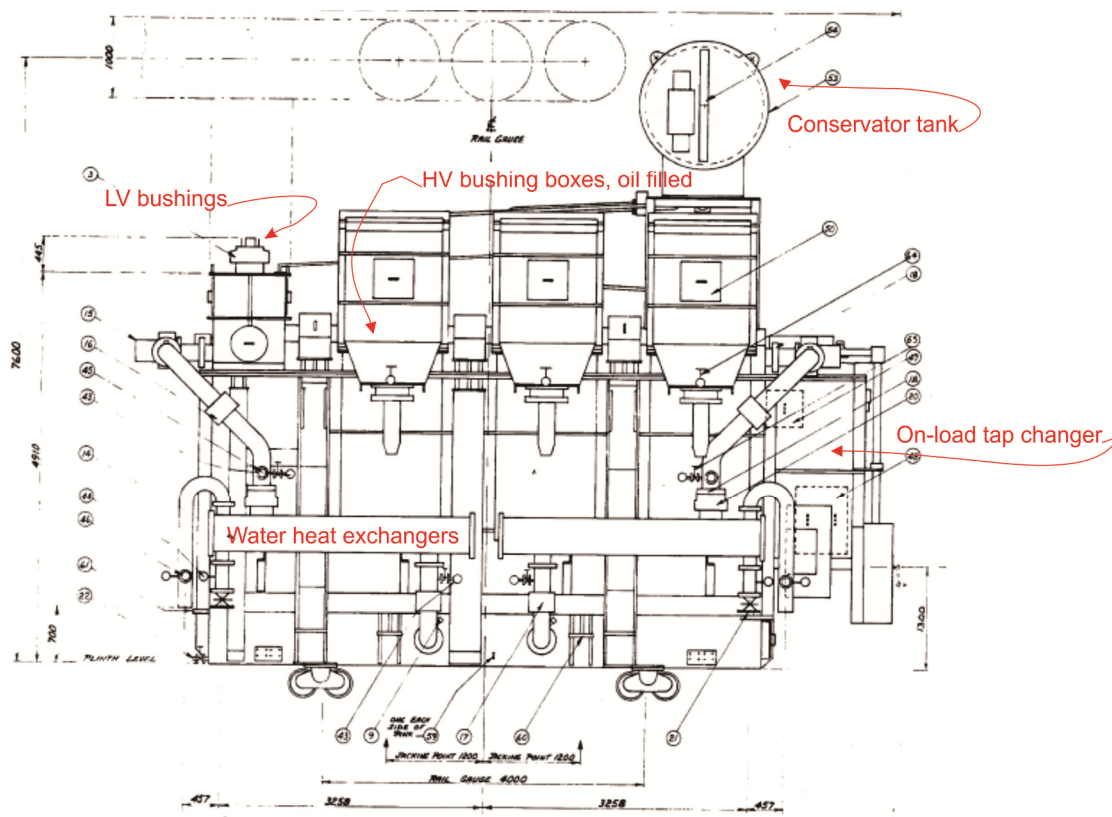
The larger of these transformers contains around 79,000 litres of transformer oil (hydrotreated light naphenic distillate, with flash point of 150°C). They have porcelain LV bushings located within steel bushing boxes (refer Figure 1).

Figure 1 Transformer components, important in explosive failure considerations.

Whilst other transformer fires have been known to eject porcelain fragments several hundred metres, for the transformers at the focus of the current study this scenario was considered to be less likely to occur due to the location of the porcelain components. In the installation of interest, porcelain external transformer bushings did not exist, and internal porcelain insulators were enclosed in the metal bushings boxes. Should the porcelain components explode, much of their energy will be absorbed by them having to penetrate the bushing

boxes, reducing their likely travel distance. Metal fragment distribution was considered more likely and has been treated as the governing case for projectiles.

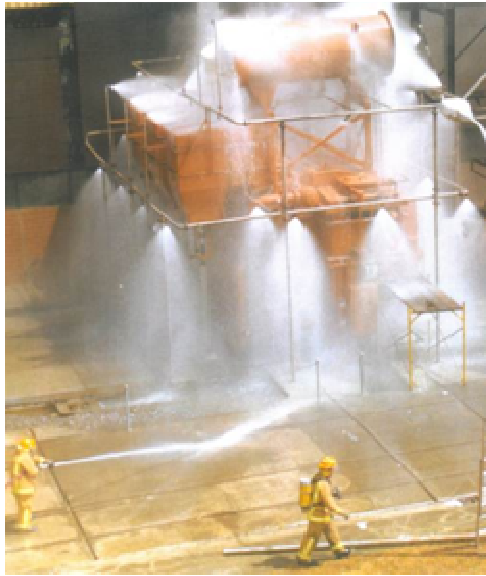
Existing mitigation measures included a dedicated high velocity water spray (HVWS) sprinkler system for each of the GSU and Unit transformers. Fire detection for this system utilised a network of pipework charged with compressed air, activated by sprinkler pilot heads and operating a deluge valve. This system would operate automatically on detection of a significant size fire in the transformers.

Each transformer had a dedicated detection and associated deluge initiation valve and operated as a “single knock” detection system. The high velocity sprays can be seen in operation in Figure 2.

Figure 2 HVWS Sprinkler system in operation on a transformer

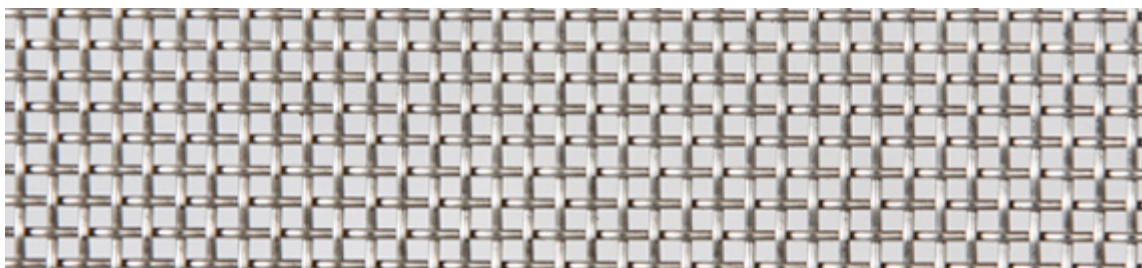
Radiation screens were considered as an alternative to the fire separations. Radiation screens, created from perforated metal sheets are typically used to protect against radiation and airborne fire brands in bushfire areas in Australia. These screens are typically created using fine stainless steel wire mesh, with apertures of less than 2mm in diameter and are tested to have a maximum radiant heat transmission of 40%. A typical example of this mesh is shown in Figure 3.

Figure 3 Close up of proposed radiation screen mesh. Wire diameter typically 0.3mm at 2mm centres

Radiation screens were selected as being the most effective option for surrounding the transformers. The installation of the screens along the edge of the bund, including across the bund between transformers would allow for staff to be working on de-energised transformers while adjacent transformers were in-service. The proposed screens were intended to be constructed with a steel frame, with mesh screens, or punched steel panels inset. Gates were proposed in these screens to allow access into the transformer enclosures when they were de-energised.
