EEA CONFERENCE & EXHIBITION 2018, 20-22 JUNE IN AUCKLAND

Paper Title: Bricks and Mortar, Fire and Water – Protecting Power Transformers at Meridian Energy’s Ohau A Power Station

Authors: Yanosh Irani (Presenter) - Meridian Energy, Gilbert Gordon – Holmes Fire, Chris Lynch – WSP Opus, Ross Major – Selkirk Consulting

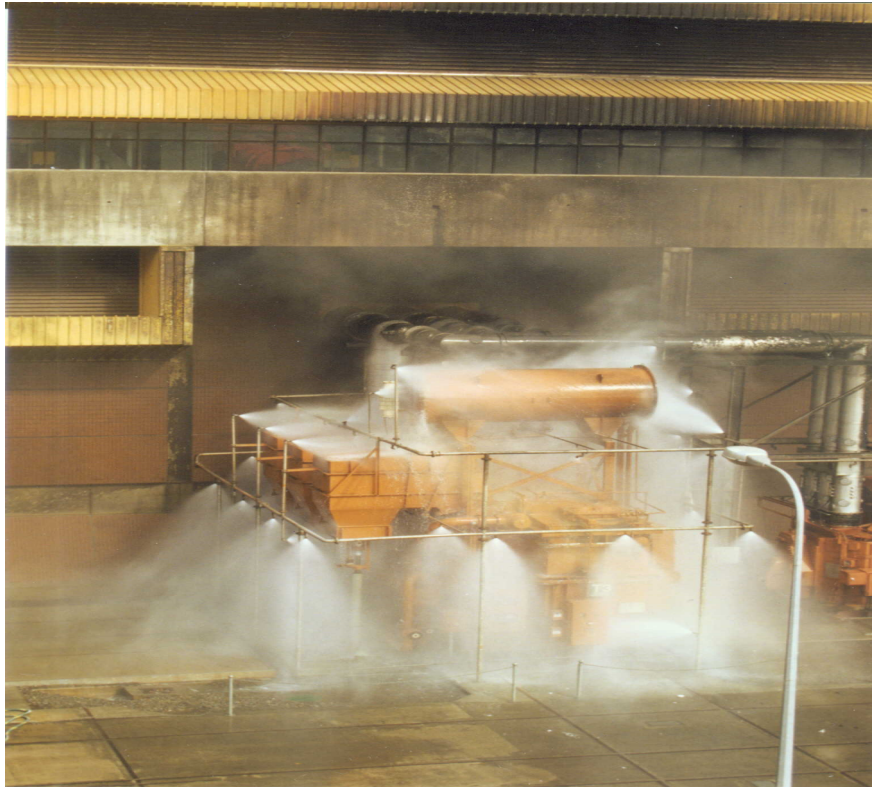
Transformer fires at power generation sites are rare. The most notable one in recent history was the Huntly fire in 1999 shown in Figure 3. The fire was quenched after 36 hours due to the significant amount of burning material. Despite being perched above an aggregate filled bund equipped with an oil interception system, trace amounts of transformer oil still entered the neighbouring river (O'Sullivan, 1999).

Figure 3: Huntly transformer fire with deluge system operating (O'Sullivan, 1999)

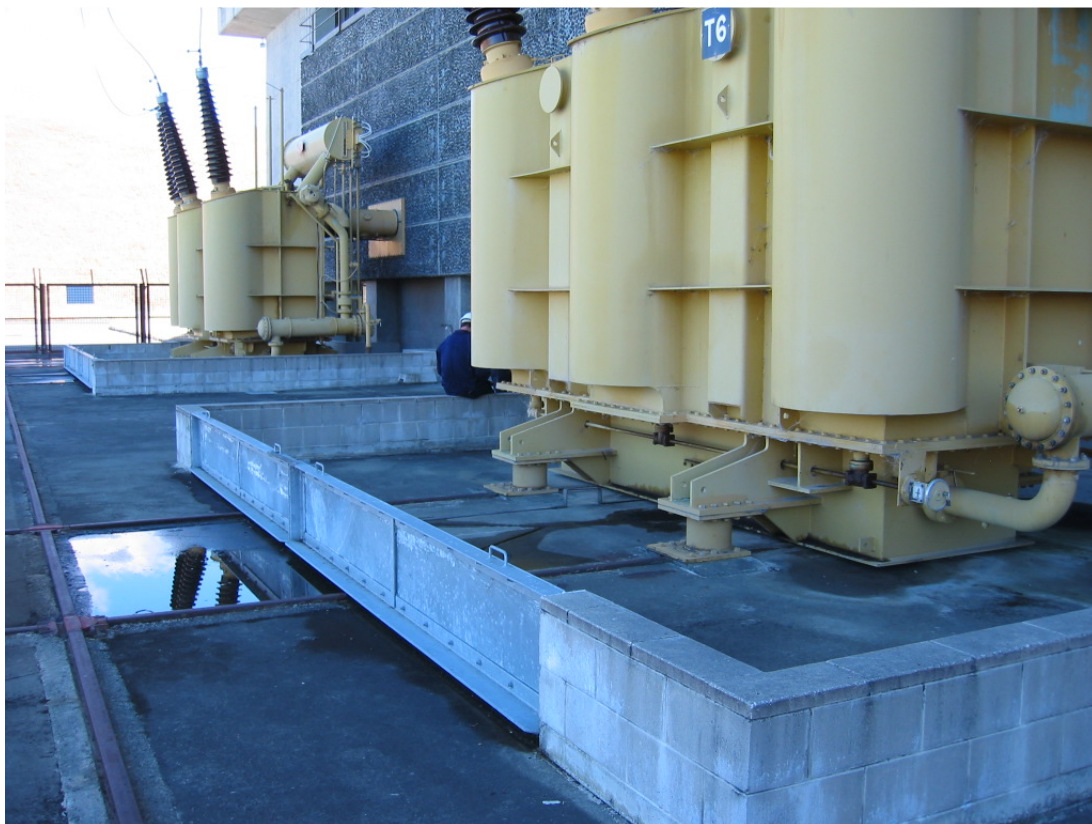
The existing transformer bunds shown in Figure 4 had been sized to contain the maximum expected spill from any one unit and had no provision for firefighting water. The bund water drainage pipework running to an oil separator was equipped with automatic shutoff valves to isolate the oil in the bund in the event of a transformer trip. This created a risk of an oil pool fire forming in the bund. The removable steel bund gates were sealed with a liquid sealant almost guaranteed to fail in a fire.

Figure 4: Old transformer bunds with steel gates

New bunds with a larger capacity were designed to comply with recommendations from NFPA 850. This included capacity to contain all oil within the transformer and 10 minutes of firefighting water. The bund drainage was re-designed to passively drain oil into a holding tank, reducing the risk of an oil pool fire. A further drainage valve was installed to enable oil removal from the tank of a burning transformer and reduce the burn time.

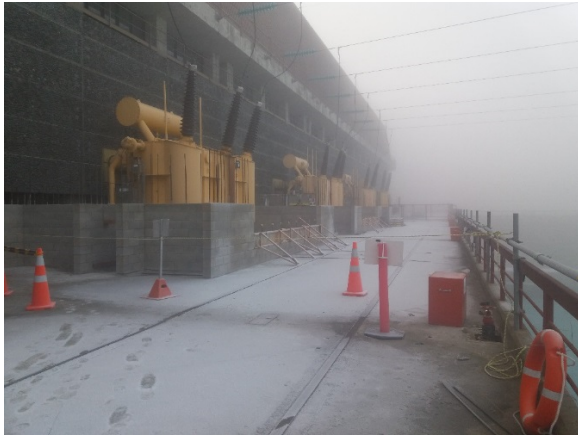
Wet and cold weather was a significant challenge during some of the works and a source of project delays. The south facing transformer platform received minimal winter sunshine and was often coated in a thin layer of ice. Blocks could not be laid on wet days nor on excessively cold days due to wet or frozen mortar. The contractor partially mitigated this risk by shrink wrapping the scaffold.

Figure 7: Winter working conditions

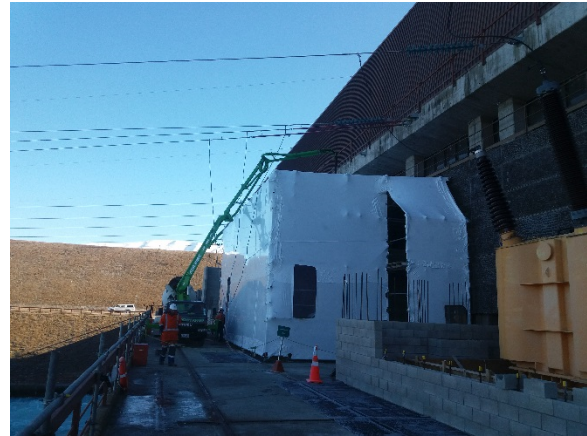
Figure 8: Wrapped scaffolding

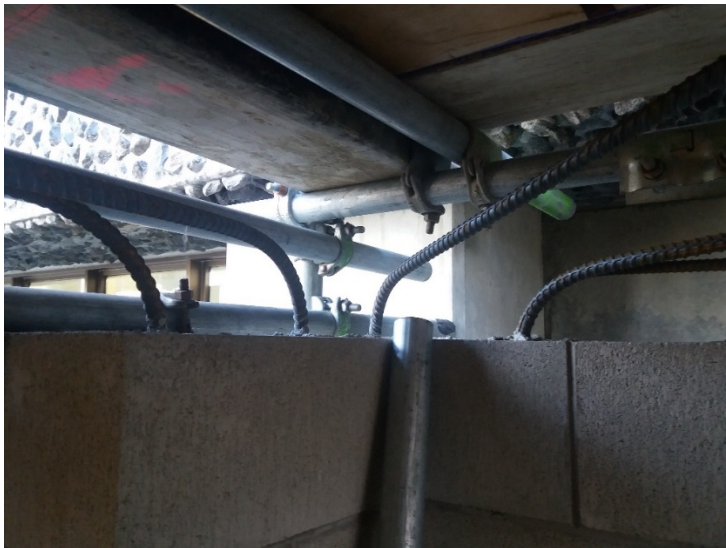
During one outage the scaffolder misinterpreted a site instruction and significantly bent 18 structural reinforcing bars to make room for a scaffold platform. The fix could have involved considerable delay but an industry best practise method involving application of heat was used to straighten the bars (CCANZ, 2005). The end result was considered significantly stronger than the alternative fixes.

Figure 9: Bent reinforcing steel

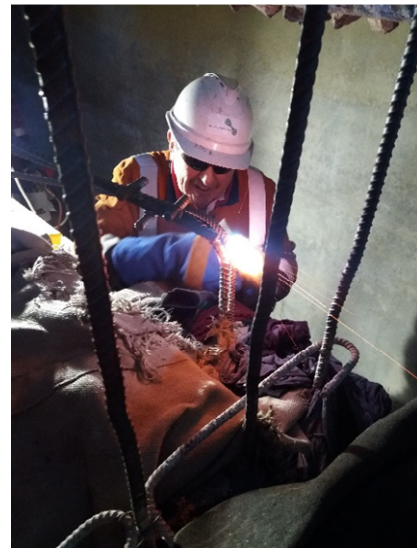
Figure 10: Re-bending with heat

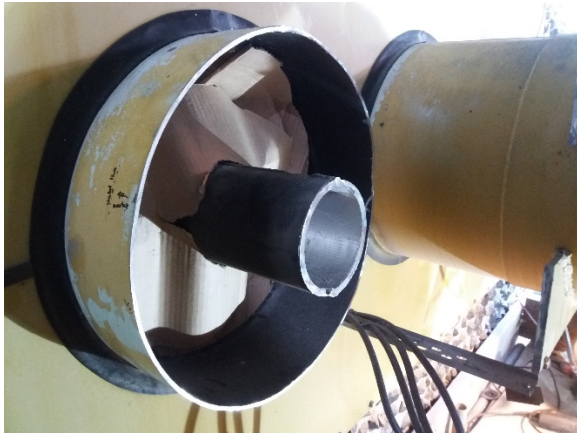
Figure 14: Cut IPB enclosure and busbar

The majority of the IPB modifications were completed before firewall construction began. The existing IPB enclosure was cut/removed, a mounting flange welded in place, the circular busbar replaced with round extruded busbar so that a good seal could be achieved and the barrier bolted in place. Attention

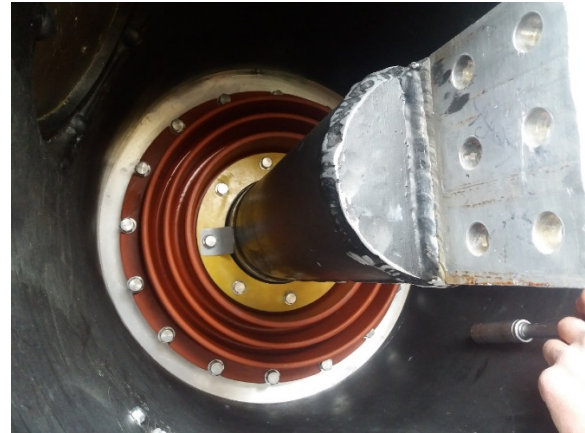
Figure 15: Fully installed oil barrier

A custom IPB seal off bushing was designed to serve as an oil barrier between the transformer LV bushings and the power house. A type tested barrier was not possible because the OEM was no longer in business. The barrier was designed from first principles such that it could be retrofitted on site. Another challenge was material selection as a true fire rated material was not available. A porcelain material was deemed impractical. The barrier was cast from a sheet moulding compound, often used in industrial applications. Manufacture was undertaken by an IPB supplier in China to a high standard, and the reasonableness of their cost made it easy to justify the employment of an independent factory QA inspector prior to dispatch.
