EEA CONFERENCE & EXHIBITION 2018, 20-22 JUNE IN AUCKLAND

Paper Title: Bricks and Mortar, Fire and Water – Protecting Power Transformers at Meridian Energy’s Ohau A Power Station

Authors: Yanosh Irani (Presenter) - Meridian Energy, Gilbert Gordon – Holmes Fire, Chris Lynch – WSP Opus, Ross Major – Selkirk Consulting

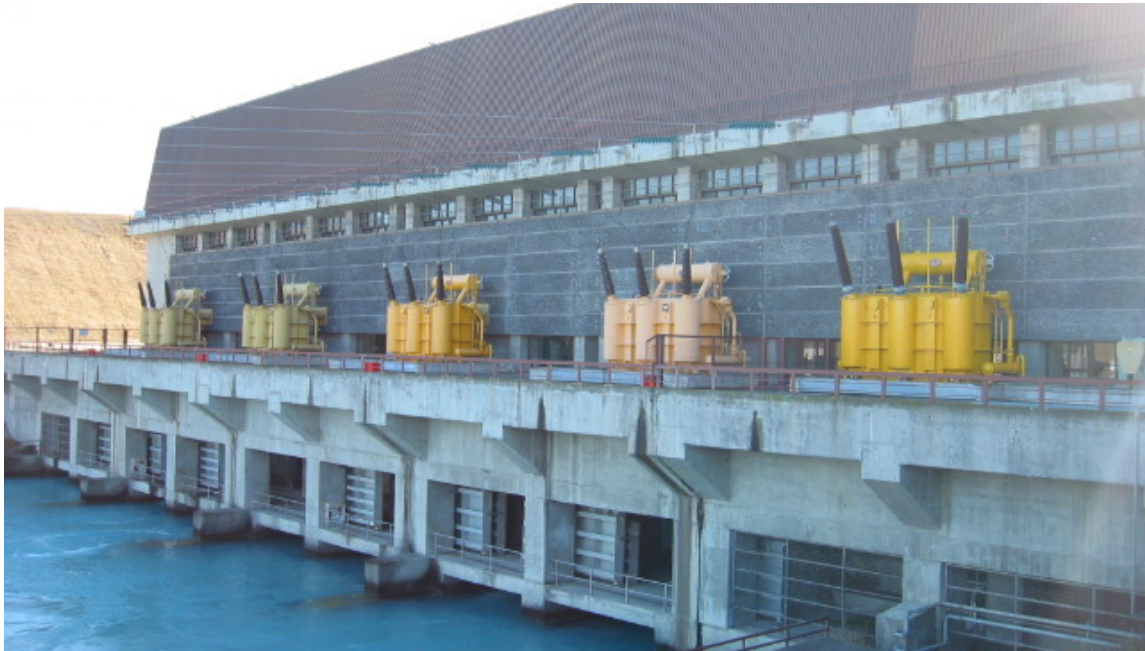
Figure 1: Ohau A transformer platform before project

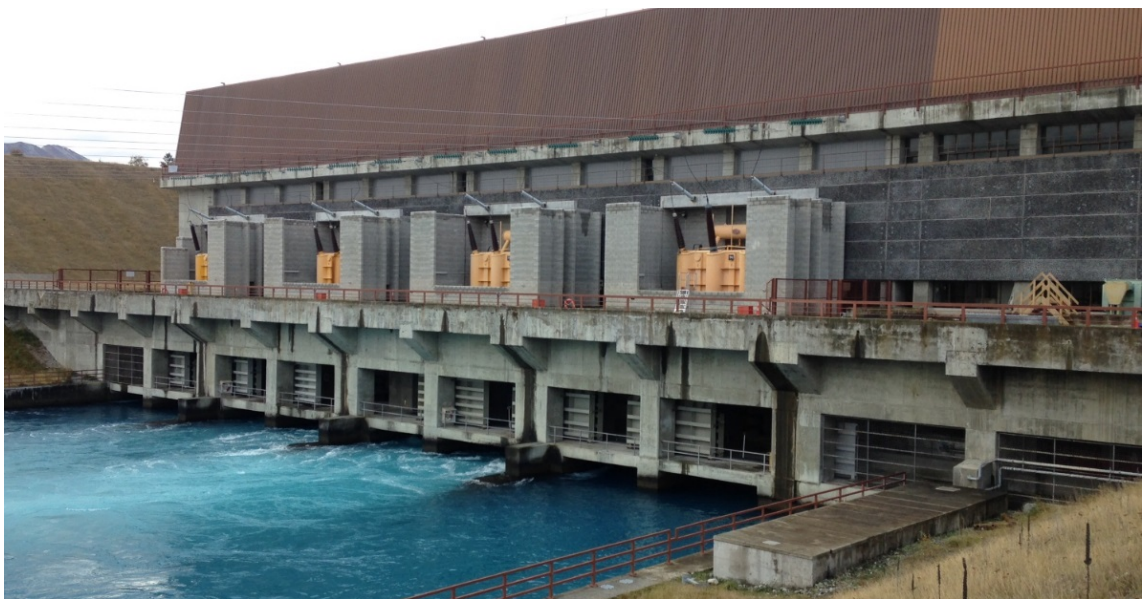
Figure 2: Ohau A transformer platform after project

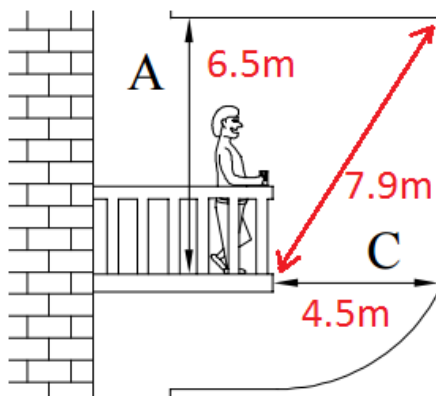
The ambiguity arises because ECP 34 implies up to a 7.9m diagonal distance may be required from the scaffolding platform to the conductor even though all workers on the platform were outside the 4m MAD to 220 kV specified in SM-EI part 2. The SM-EIs do not provide an allowance for mobile plant to be constructed within ECP 34 distances (see rule 3.712) but do have an allowance for mobile plant (see rule 3.713). This implies that laying blocks from mobile plant whilst impractical would comply with ECP 34 and the SM-EIs.

Figure 5: Minimum clearances specified in ECP34

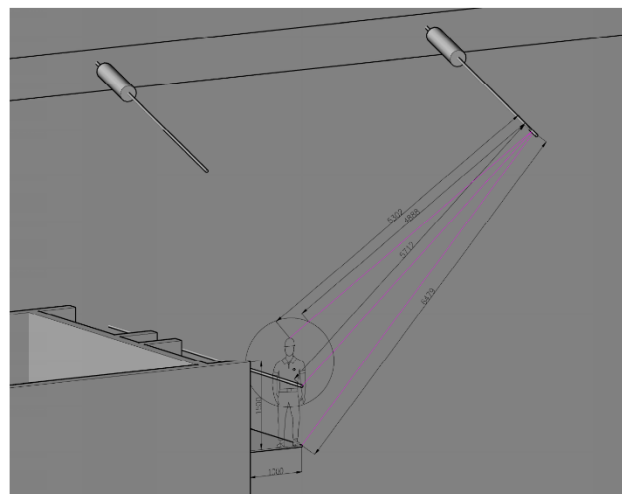
The most challenging health and safety risk to manage was the proximity of live 220 kV conductors to the work party. This risk was eliminated during high risk tasks such as scaffolding by scheduling short unit outages timed to suit favourable market conditions between demand peaks. At other times the works were carefully managed with safety observers and barriers. A 3D model of the scaffold was produced to predict the clearances to neighbouring unit live lines as shown in Figure 6.

Figure 6: 3D model of scaffold and clearances to 220 kV lines

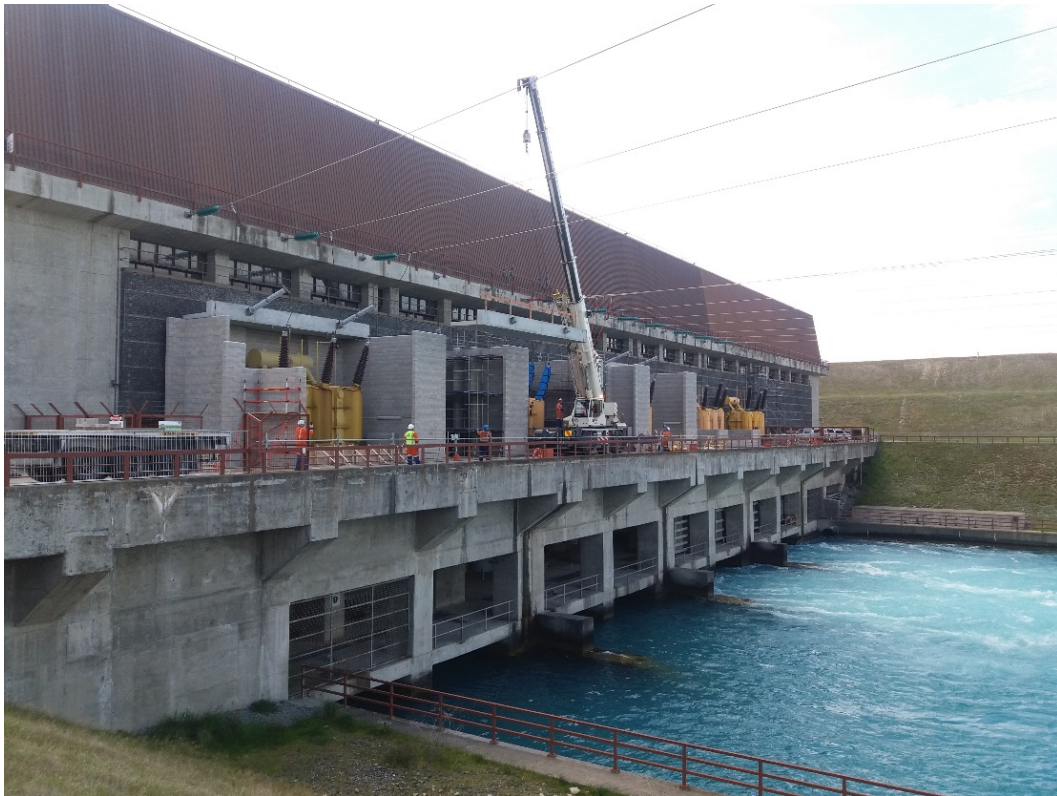
The cold weather presented further challenges with concrete curing times slowing to a crawl below 10 °C. The final installation of the pre-cast canopy was contingent upon the supporting concrete pour attaining a minimum compressive strength. Conditions were so cold adequate curing was not guaranteed. To prevent delays, supporting props were installed to hold the canopy. Final compressive test results of sample concrete cylinders were just within the requirements after days of curing.

Figure 11: Pre-cast canopy installation

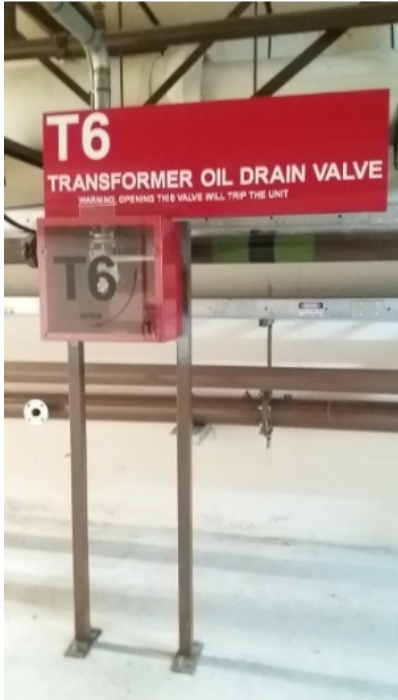
The new transformer drain valve pipework required core drilling through the transformer platform in the presence of numerous embedded services of unknown locations. The exact locations of critical pipework and cabling was ascertained accurately by a ground penetrating radar scan through the 1 m thick platform.

Figure 12: Emergency oil drain valve

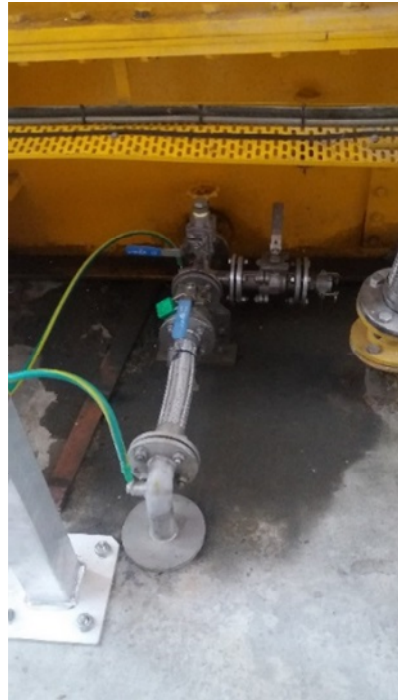
The second challenge was priming the pipe between the transformer tank and the new drain valve without displacing an air bubble into the transformer. This section of pipe was vacuum primed which had not been specified in the original design brief. Some of the joints were modified to make them vacuum rated and a vacuum filling procedure was developed to complete the installation.

Figure 13: Drain valve transformer connection

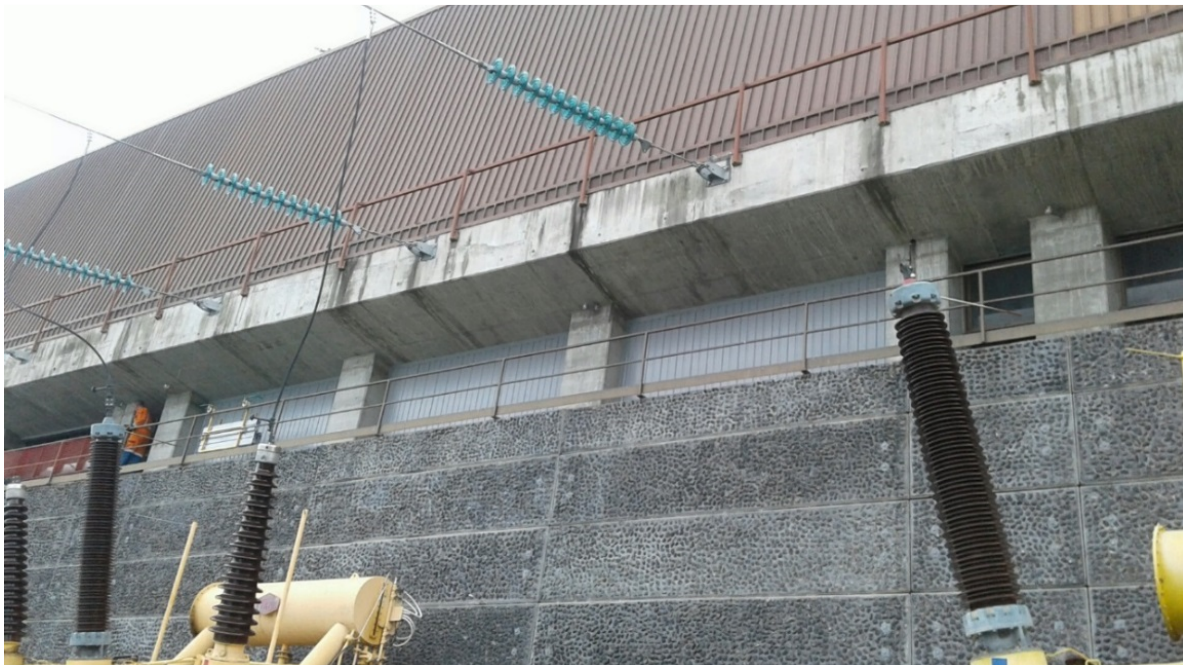
This item of scope presented the greatest savings from the original budget. The original design spec called for a fire proofing solution that would not change the appearance of the building so internally mounted fire board was proposed. The contractor suggested installing exterior mounted aerated concrete panels from the existing walkway to save scaffolding costs. Panels were raised up using a forklift then transported along the platform using a custom built trolley. The original design requirement was relaxed as there would be little difference in the appearance of the building. The time and cost savings were significant and a number of project risks were eliminated using this approach.

Figure 16: Completed Speedwall® window protection showing transport trolley on left
